CHAPTER 2

EXISTING FACILITY

2.1 Route 99 Background

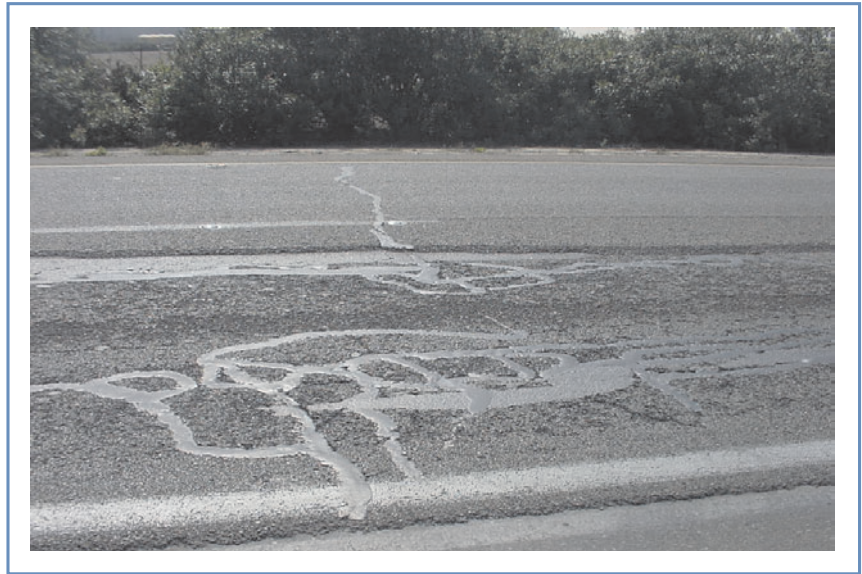
Figure 2-1
Surface cracking on Route 99

Today, trucks make up as much as 30 percent of the traffic on Route 99 compared to a state-wide average to about 9%. Extra stress from the weight and amount of truck traffic on a aging pavement is the biggest factor in the poor pavement conditions (Figure 2-1). A bumpy ride is the most obvious sign of

pavement failures. The poor ride is caused by faulting (settlement across concrete joints), concrete pavement or supporting base failures, and aging asphalt overlays that need more frequent rehabilitation. The best long-term solution is complete concrete pavement reconstruction. However, because of construction duration constraints, reconstruction of concrete pavement is problematic and costly.

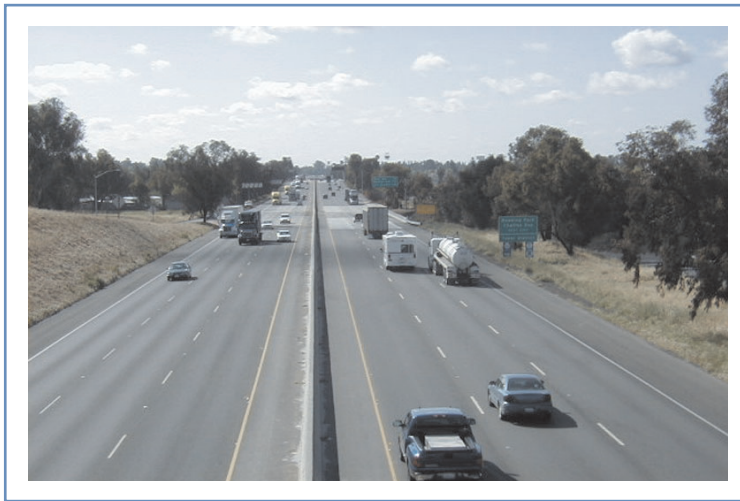
Figure 2-2
Concrete Safety-Shaped Median Barrier

Median barriers are used on divided highways to reduce the risk of an out-of-control vehicle crossing the median and colliding with opposing traffic. The approved standard types of median barriers for new installation are concrete safety-shaped barriers (Figure 2-2) and metal thrie-beam barriers (Figure 2-3). Temporary concrete barriers (type K) may be used under certain condi-

tions. These median barriers are capable of preventing nearly all of the cross-median accidents.

The median widths vary significantly in a corridor of this length. For median widths equal to or less than 36 feet, concrete barriers are preferred; three-beam barrier is typically used in wider medians or medians with existing plantings

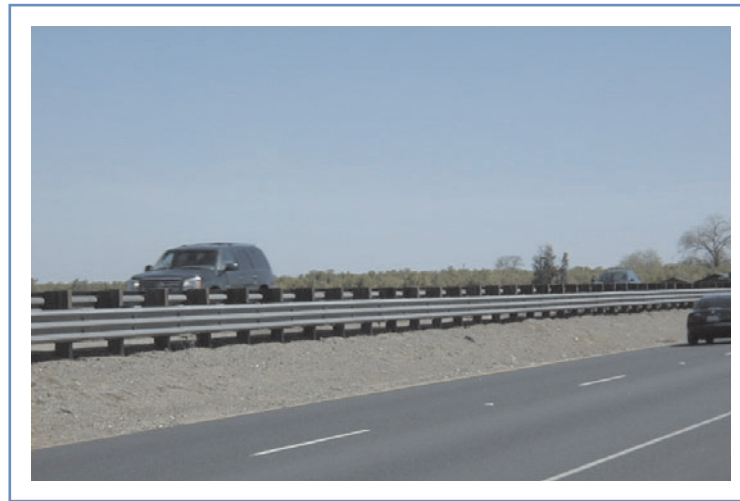
Figure 2-3
Thrie-Beam Median Barrier

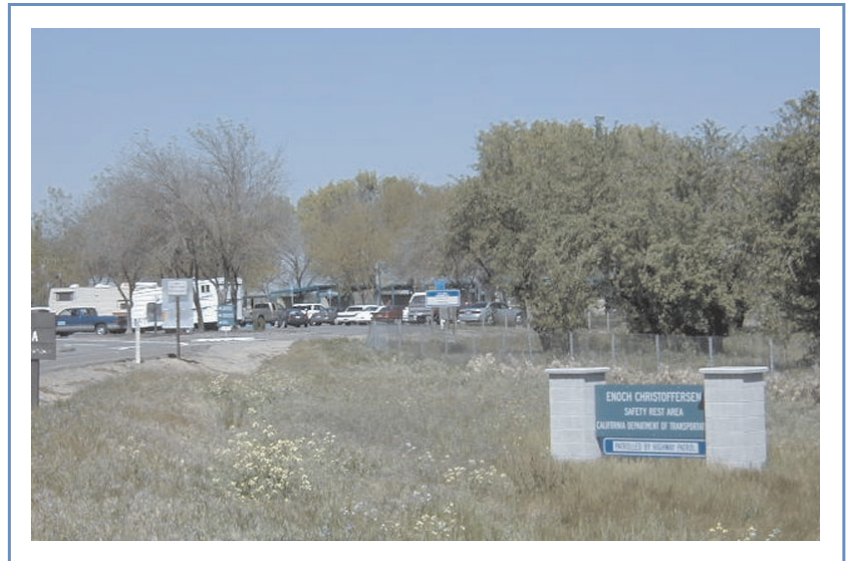
Figure 2-4
One of the three rest areas on Route 99 between Lodi and Bakersfield

Caltrans provides "Safety Roadside Rest Areas" for motorists to stop and rest for short periods (Figure 2-4). These rest areas

include parking areas, drinking water, toilets, tables, benches, telephones, and information panels. Some rest areas may also include other facilities for motorists.

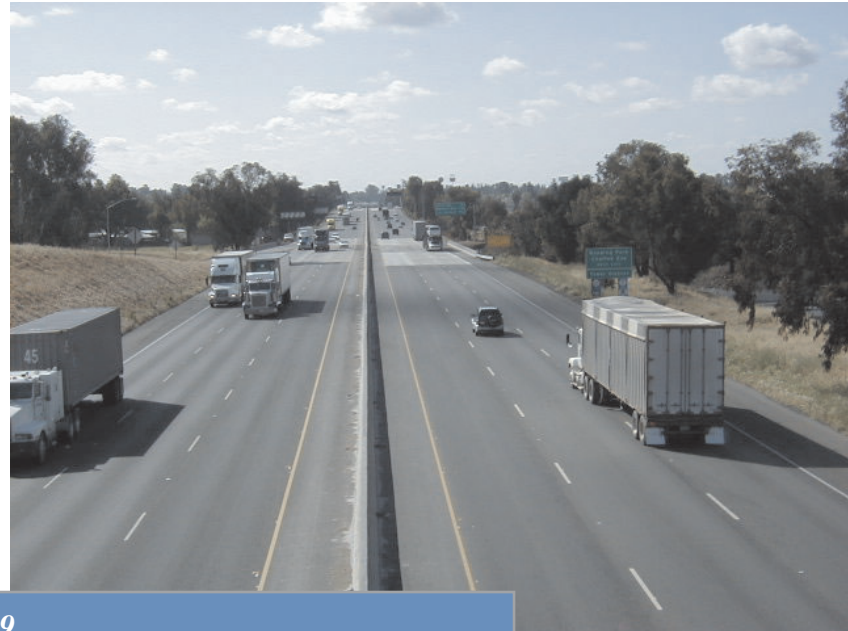
Figure 2-6
Truck Traffic on
Route 99

The percentage of truck traffic on Route 99 may have the greatest effect on capacity. Other physical characteristics that affect capacity include the number and width of lanes; the location, spacing, and type of interchanges; the presence and width of shoulders; the condition of the pavement; and gaps in the freeway system. There will be a significant need to add lanes on Route 99 over the next 25 years, but right-of-way and environmental constraints will put limits on what can be built.

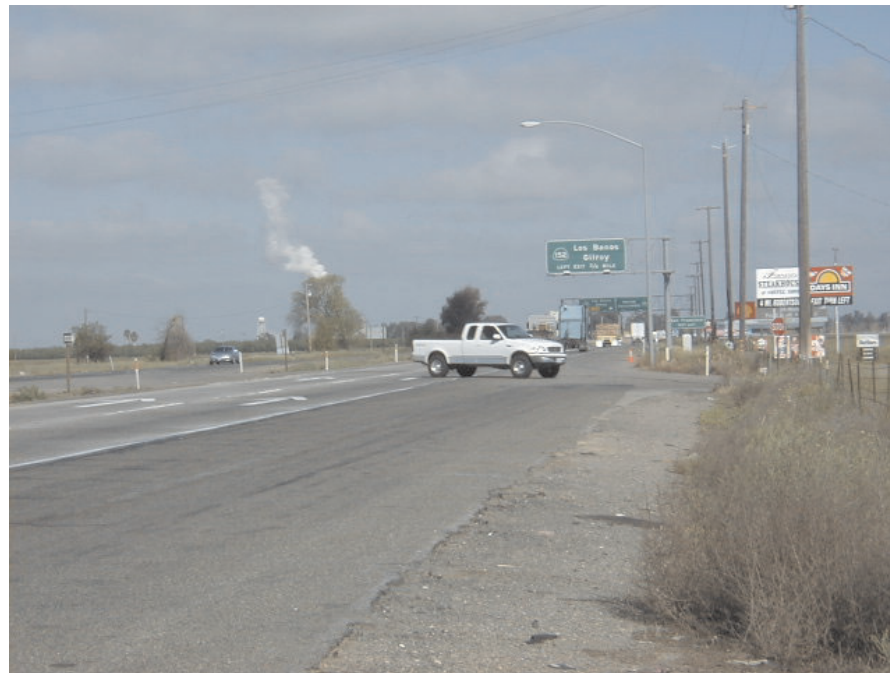
Figure 2-7
A pickup crosses traffic at a “freeway gap” on Route 99

The average motorist is inclined to drive Route 99 as if it were all freeway. In fact, Route 99 has segments that are not freeway because they include at-grade intersections where cross traffic enters and leaves the expressway without the benefit of an interchange (Figure 2-7). These segments are called “freeway gaps” and are in reality expressways. Caltrans is aware of these gaps and continually monitors the traffic volume and turning movements. Many gap segments have been converted eliminating signal lights and to freeway, congestion. Land use changes can also trigger the requirement to convert from expressway to freeway.

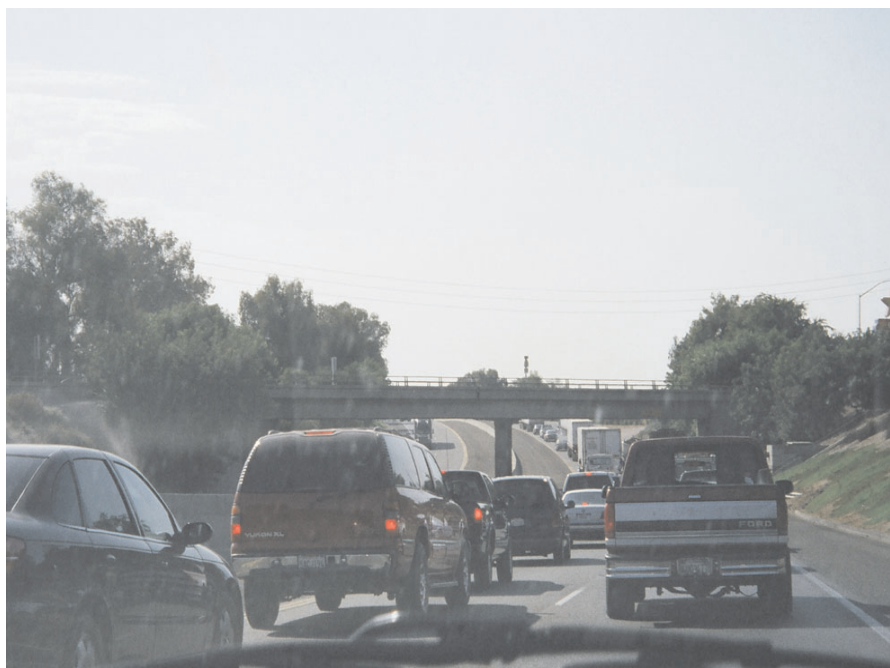
Figure 2-8
Congestion on Route 99

ciently through interchanges depends largely on the type of ramp, ramp volumes, and conditions between the ramp connections and local roads. Today, simple modifications to existing interchanges on Route 99 are limited by the state-owned right-of-way and local development. Spot congestion or bottlenecks are becoming more common as traffic volumes increase (Figure 2-8).

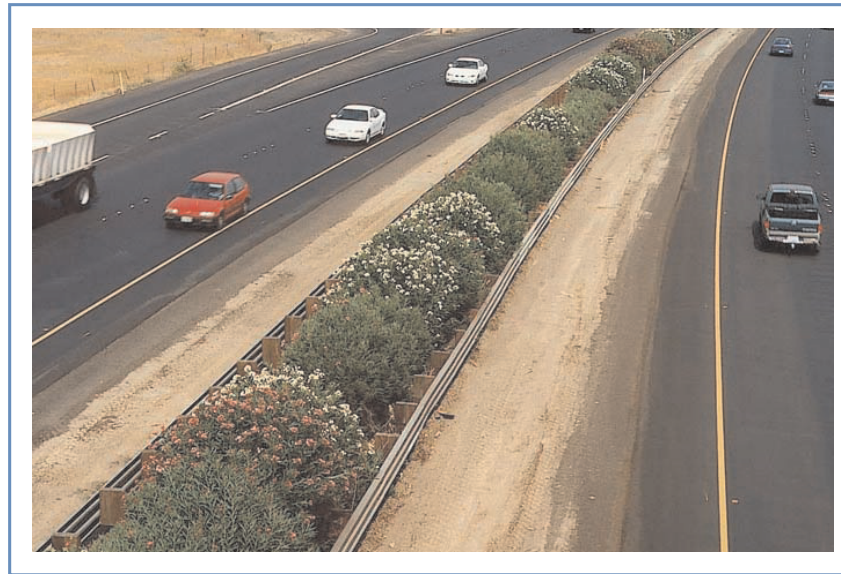
Figure 2-9
Oleander shrubs in the median on Route 99

Oleander planting in the median has come to symbolize Route 99 (Figure 2-9). In recent years, many miles of this signature element have been removed. Many more miles have been identified for removal, to help make way for additional lanes of traffic. Throughout the corridor, “Highway Planting” signifies urban areas. “Highway Planting” goes beyond pure function. It improves

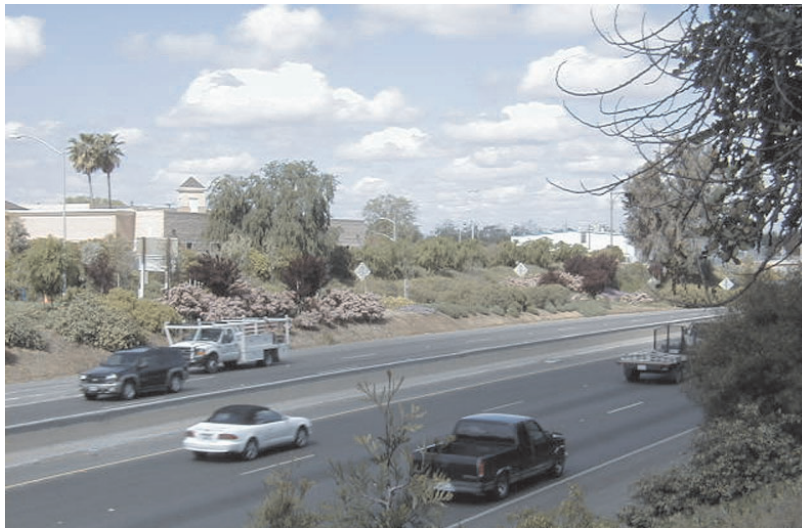
Figure 2-10
“Highway Planting” on Route 99

aesthetics and makes the roadway more compatible with the surrounding urban environment of neighborhoods and businesses (Figure 2-10). Highway planting includes trees, shrubs, and ground-

covers with automatic irrigation systems. Although aesthetic in nature, this landscape also serves many functional purposes, such as controlling dust and erosion, providing fire and weed control, delineating the route, and providing headlight screening (Figure 2-9). Planting is also used to screen objectionable views of adjacent properties, as well as to screen the roadway from the community. In addition, roadside planting can act as a frame for distant vistas.

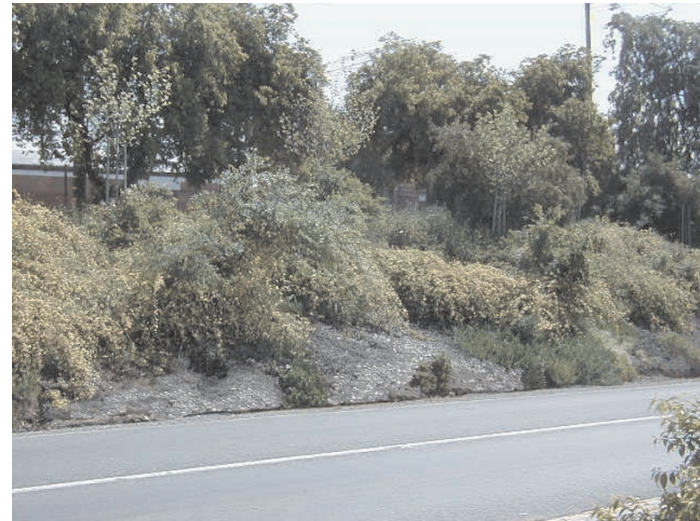
Figure 2-11
Landscaping on an off-ramp

increase in roadside landscaping, a smaller work force, and increased efforts to control graffiti and litter, have reduced the ability of maintenance staff to keep highway facilities in “as built” condition. Figures 2-11 and 2-12 show good examples of landscaping alongside Route 99. The creation and retention of a positive highway appearance requires ongoing attention to the following issues:

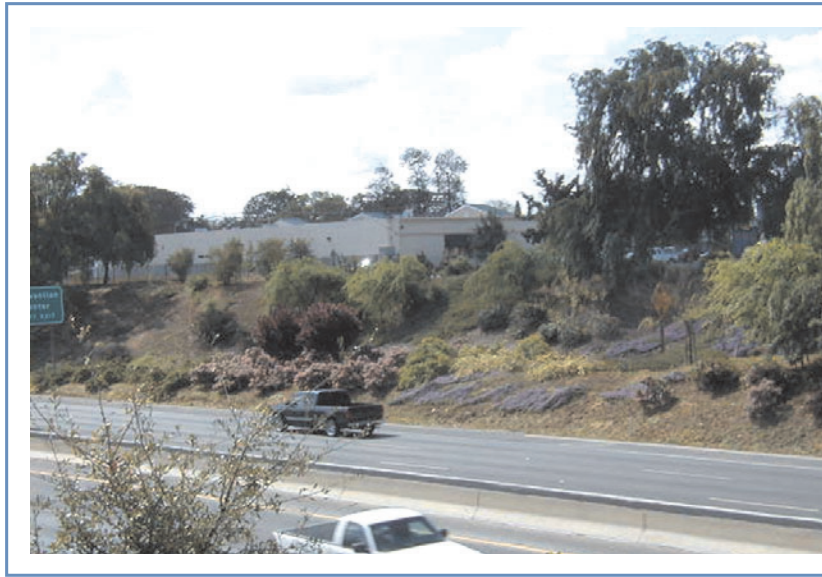
Figure 2-12
Well-maintained roadside area on Route 99
